Rimkus Consulting Group, Inc.
Eight Greenway Plaza, Suite 500
Houston, TX 77046
(800) 580-3228 Telephone
(713) 623-4357 Facsimile

Re: RCG File No: 11009971
LLV Number: 0209452
VMF Location: 1530 Greensmark Drive in Houston, Texas
Subject: Final Report

Rimkus Consulting Group, Inc. was retained to examine LLV 0209452, VIN 1GBCS10E4M2908832. The fire occurred on June 13, 2016 at around 12:30 P.M. the operator of the vehicle at the time of the fire, was unavailable for interview but reportedly stated the vehicle's engine died while delivering mail on his route and backfired during subsequent attempts to restart it. Soon thereafter, smoke was observed from beneath the hood as well as flames.

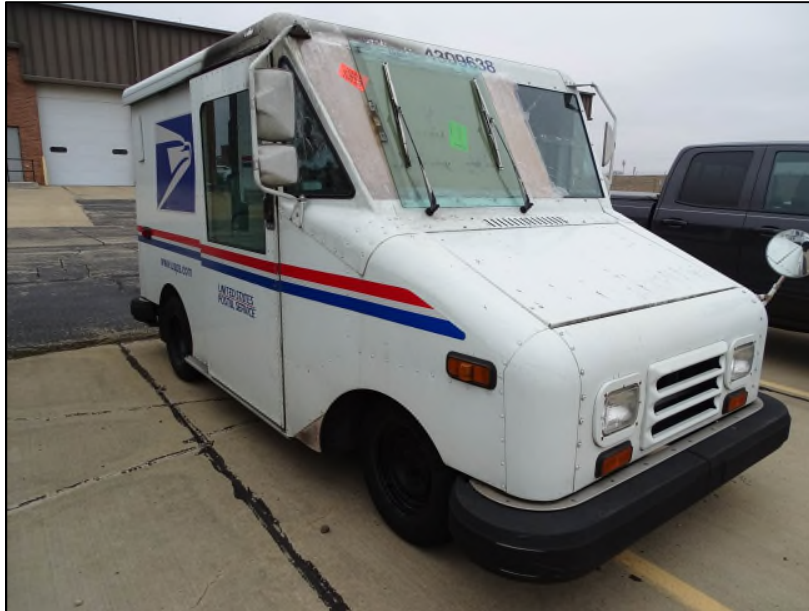
Photograph 1

1994 Chevrolet LLV 4309638, VIN 1GBCS1044R2915617.

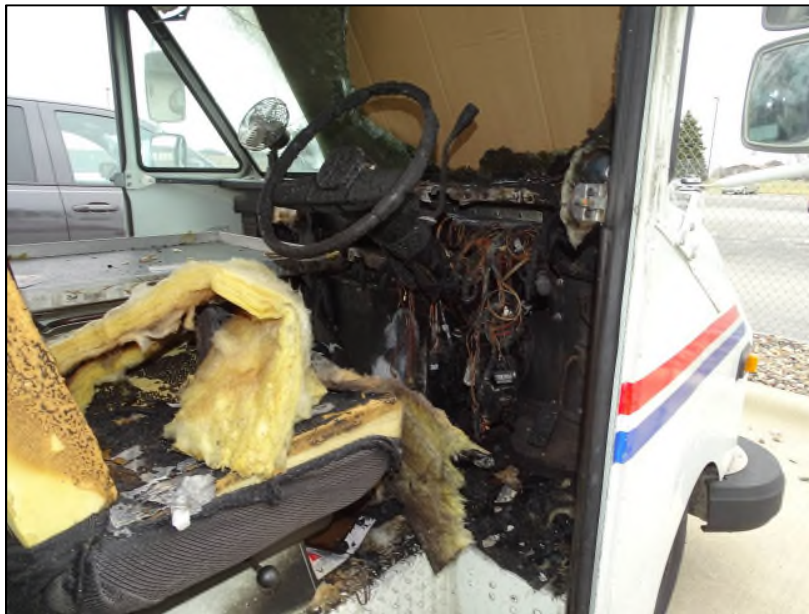
Photograph 2

Fire damage to right side of passenger compartment.

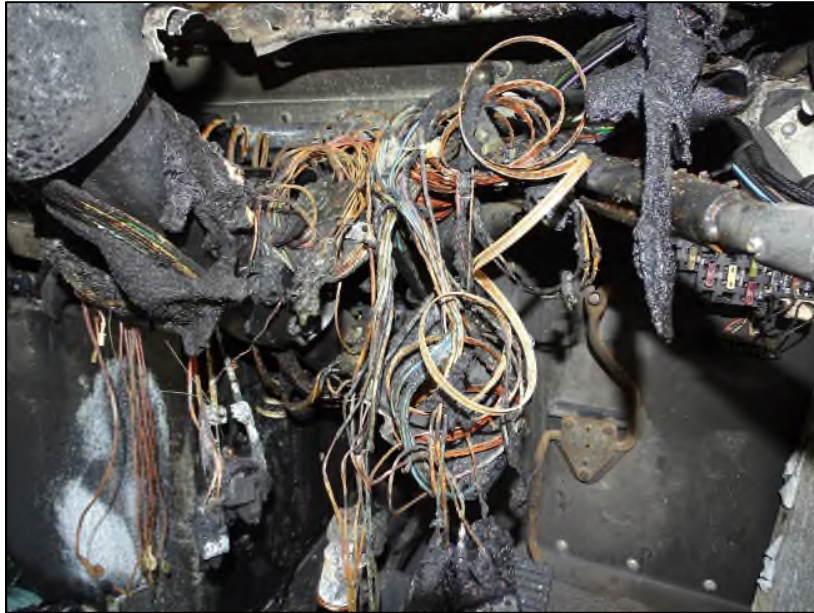
Photograph 3

Insulation intact on electrical conductors right side of dashboard.

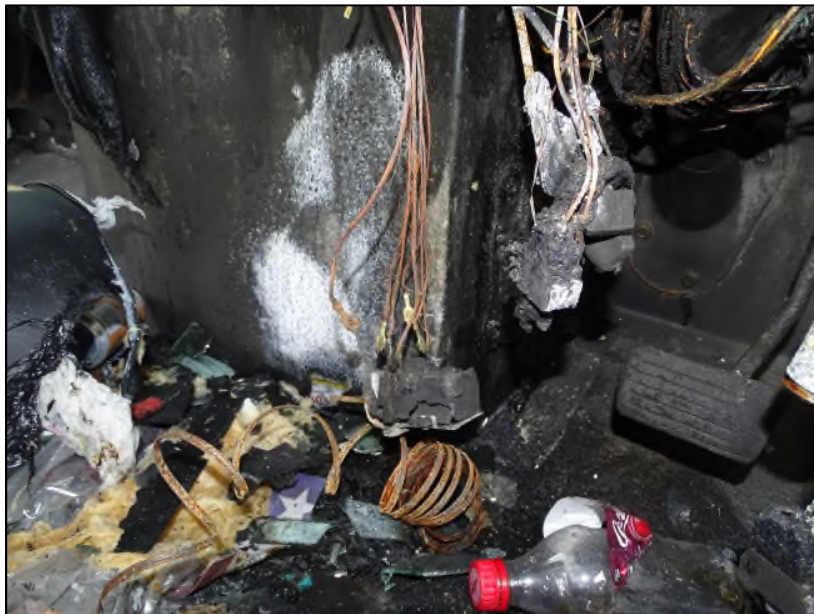
Photograph 4

Fire damage to headlamp switch and lack of insulation on conductors.

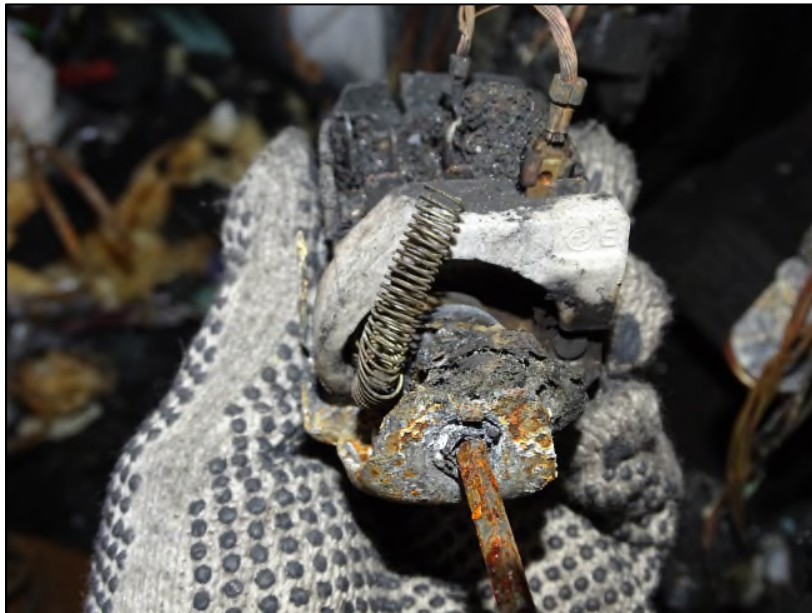
Photograph 5
Damage to headlamp switch.

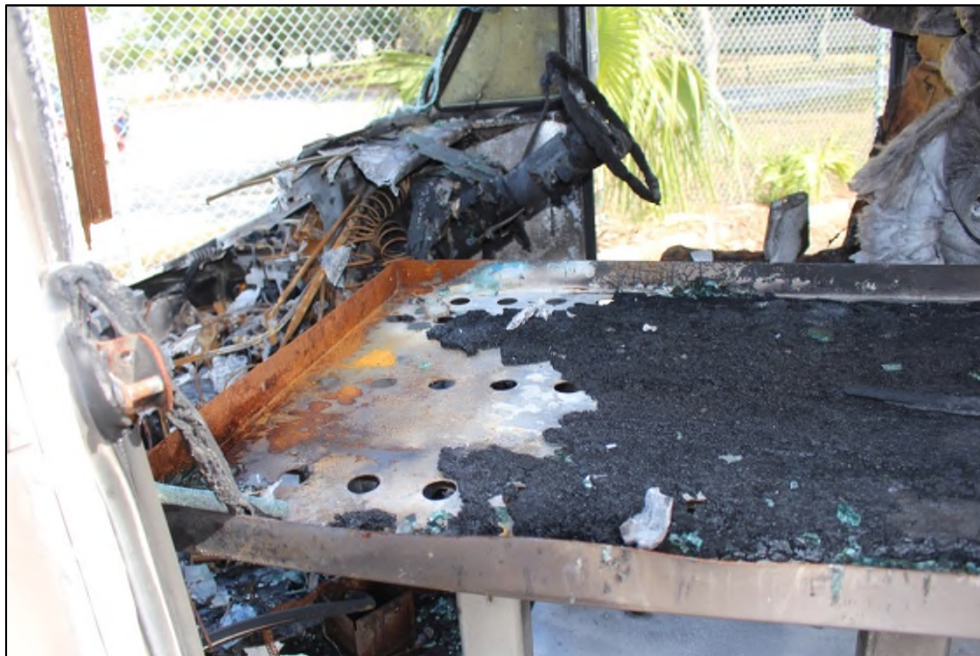
Photograph 4

Examination of the interior of the LLV revealed the fire had communicated into the operator's compartment via the bulkhead during the fire development. The mail side of the compartment sustained more severe damage compared to the driver's side with the dashboard being consumed along the mail side of the vehicle. The cargo compartment sustained only smoke and soot damage and no active fire damage.

A view of the operator's compartment of the vehicle.

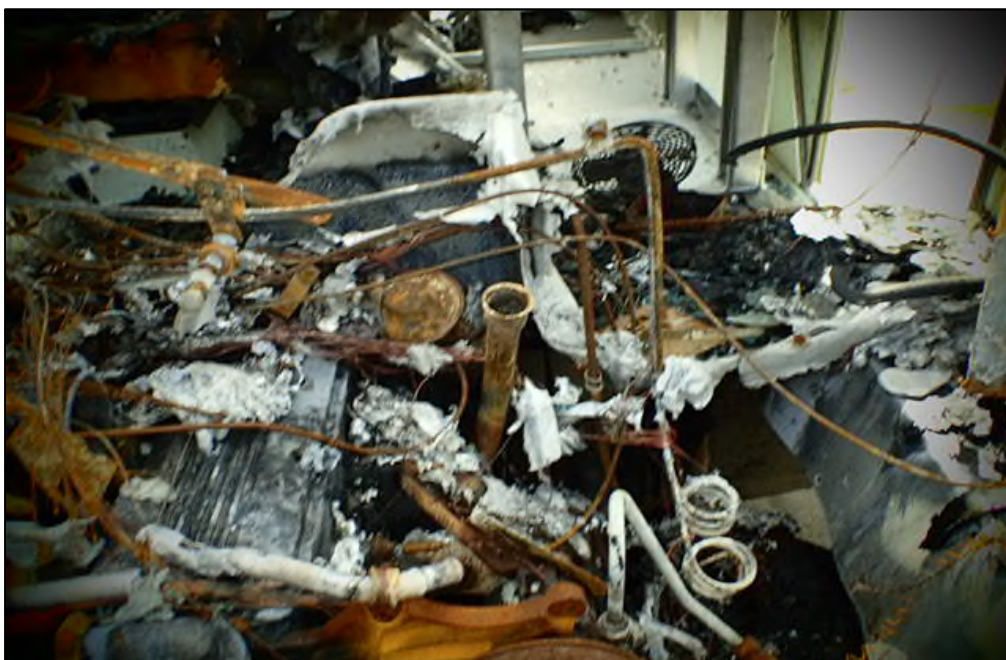
Photograph 6

Burn pattern analysis and an examination of the remaining physical evidence within the engine compartment revealed that the fire originated along the mail side of the engine compartment. We observed all of the combustible material along the mail side of the engine had been consumed. The LLV was equipped with a 2.2L engine and was fuel injected with a standard coil. We were able to detect acceptable levels of both oil and transmission fluid. The battery sustained moderate fire damage.

The area of fire origin was determined to be along the mail side of the engine compartment. Severe fire damage was observed and no obvious signs of failure were observed. Additional destructive testing by an engineer of the engine would be needed to determine the exact cause of the fire.

A view of the fire damaged engine compartment.

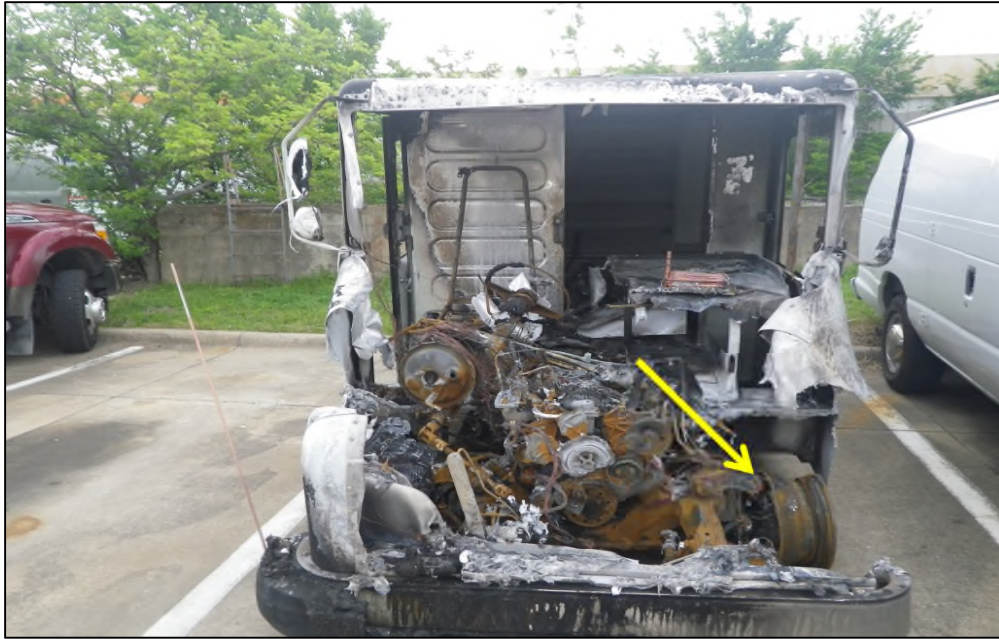
Photograph 1

View of front of LLV, Arrow indicates area of origin.

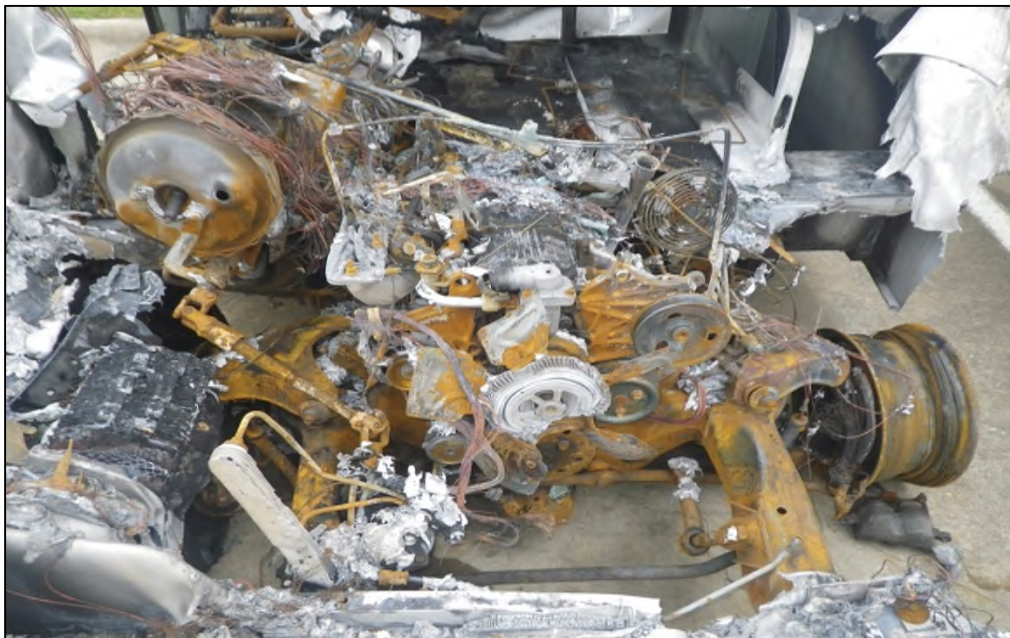
Photograph 4

The engine compartment, observe the severe fire damage to the left side and total mass loss to the combustible components of the compartment.

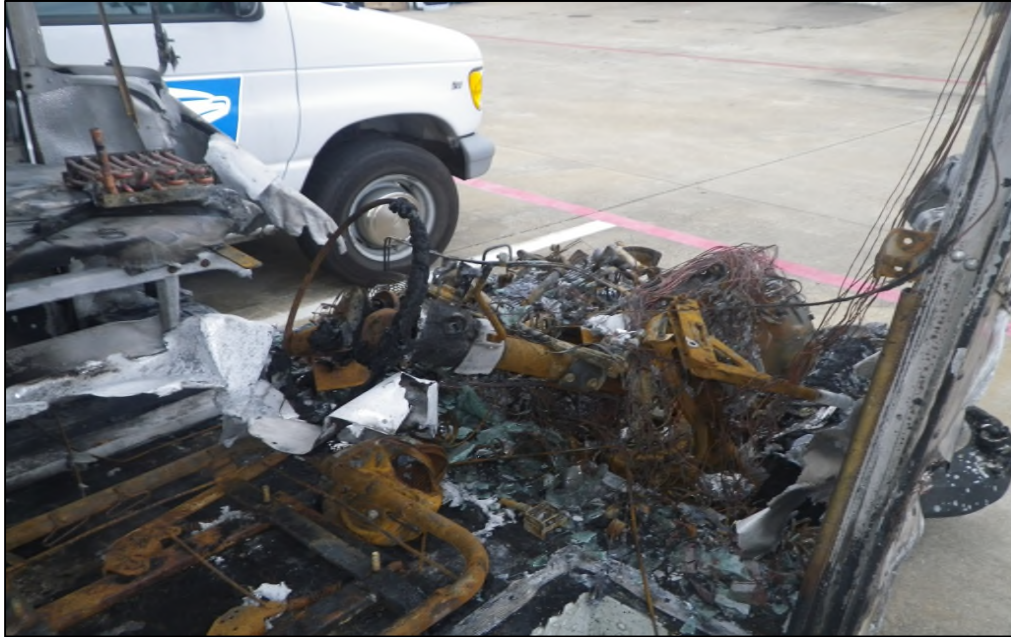
Photograph 5

View of fire damage to driver side of operator compartment, and rear of engine compartment.

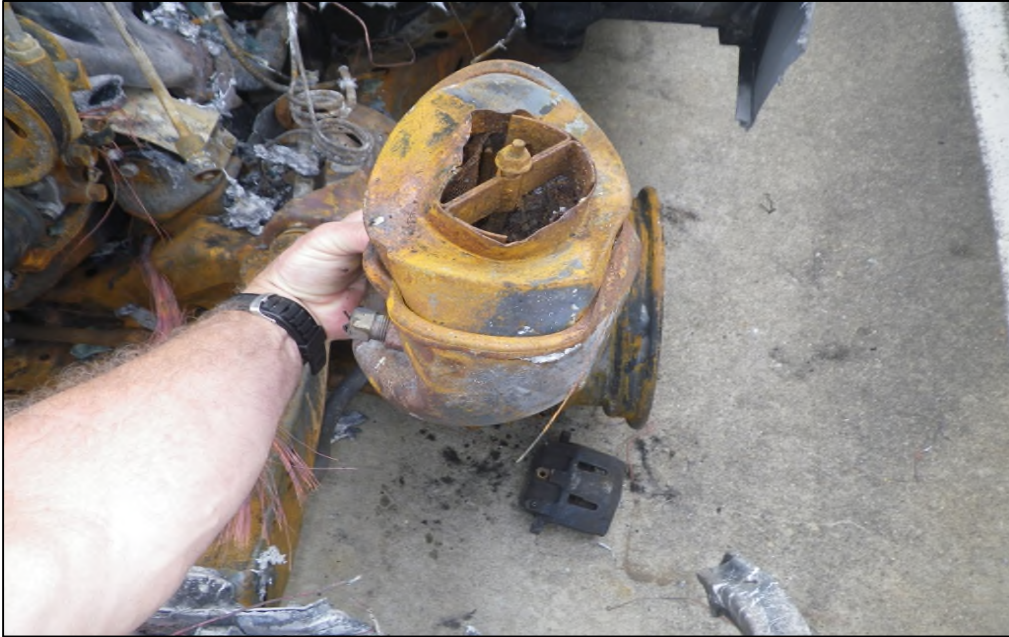
Photograph 7

View of damaged metal air filter, being placed as close to its original place before the fire, on front left engine compartment.

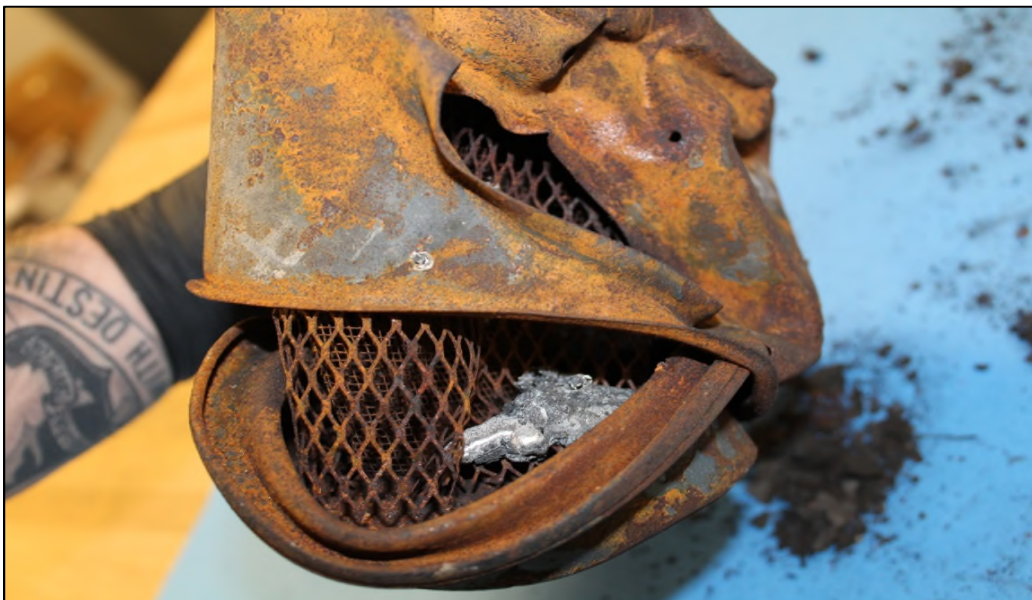
Photograph 8

The remains of the metal housing and air filter system, observe the outward progression of the metal housing unit.

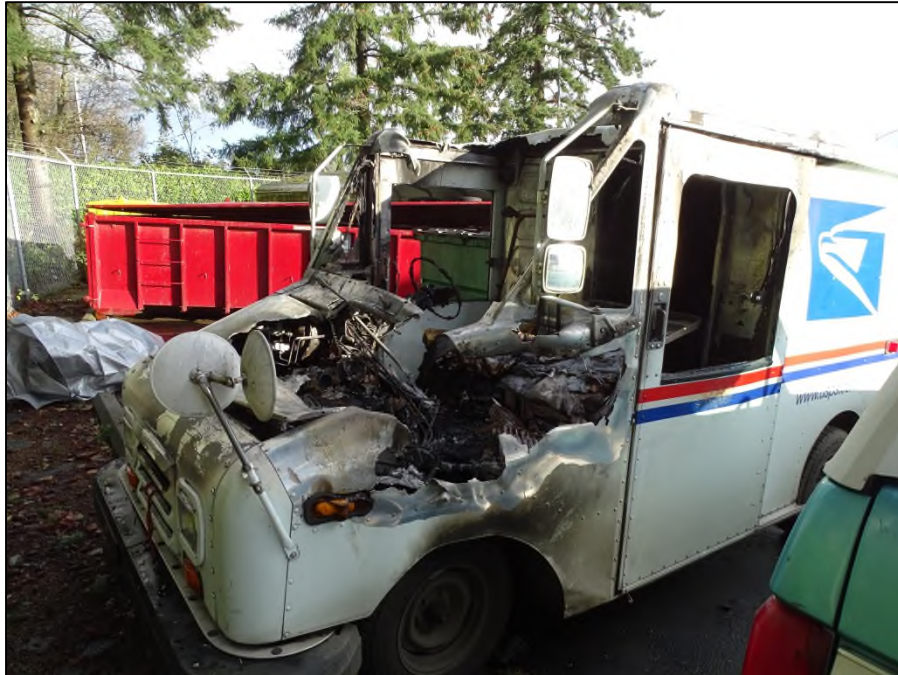
Photograph 1

Thermal damage to the vehicle on the side opposite the driver.

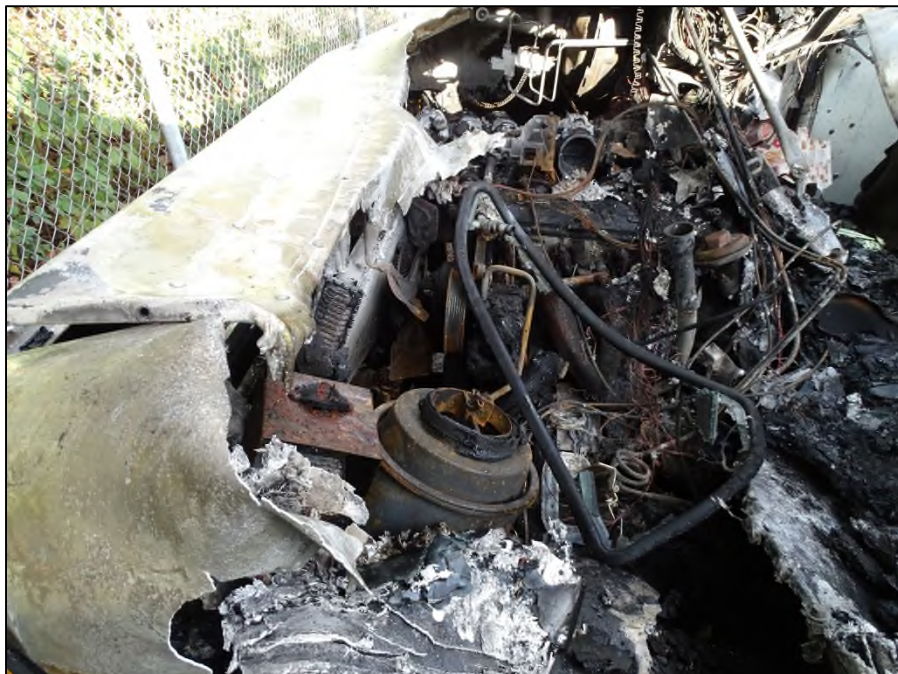
Photograph 2

Thermal damage to the engine compartment.

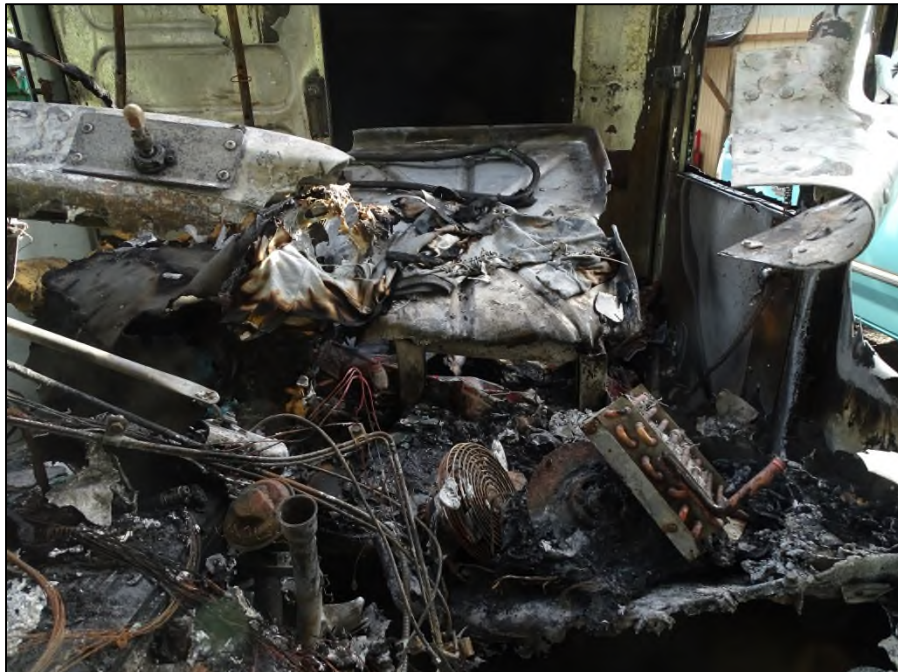
Photograph 4

General area of fire origin.

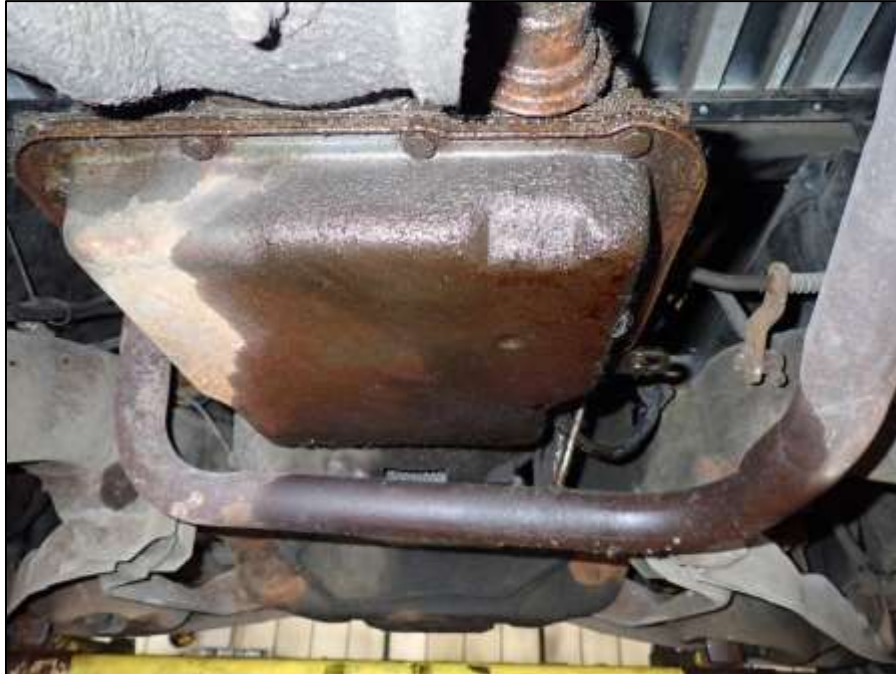
Photograph 3

Transmission fluid on pan and exhaust pipe.

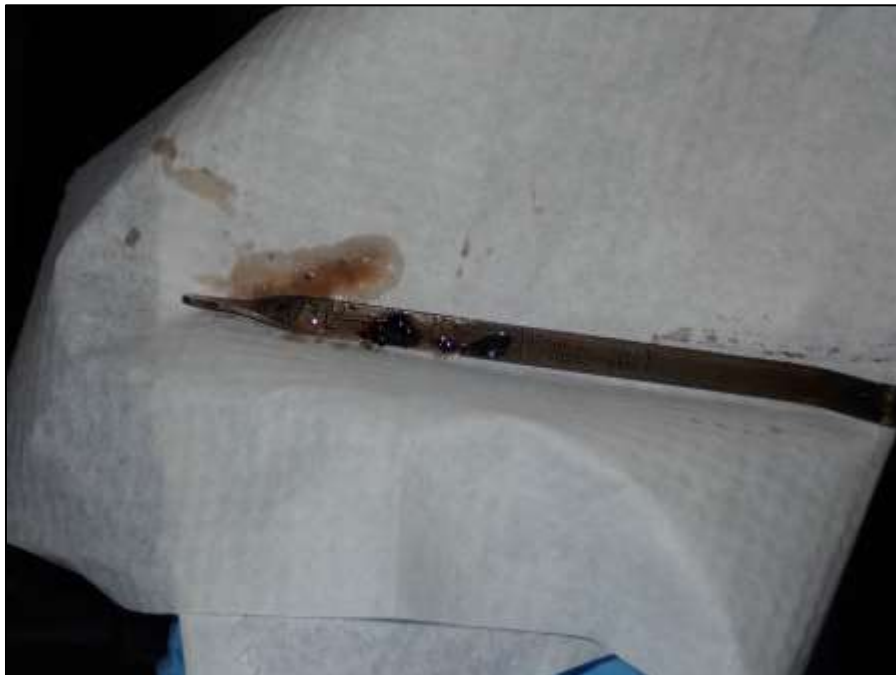
Photograph 4

Debris on transmission dipstick .

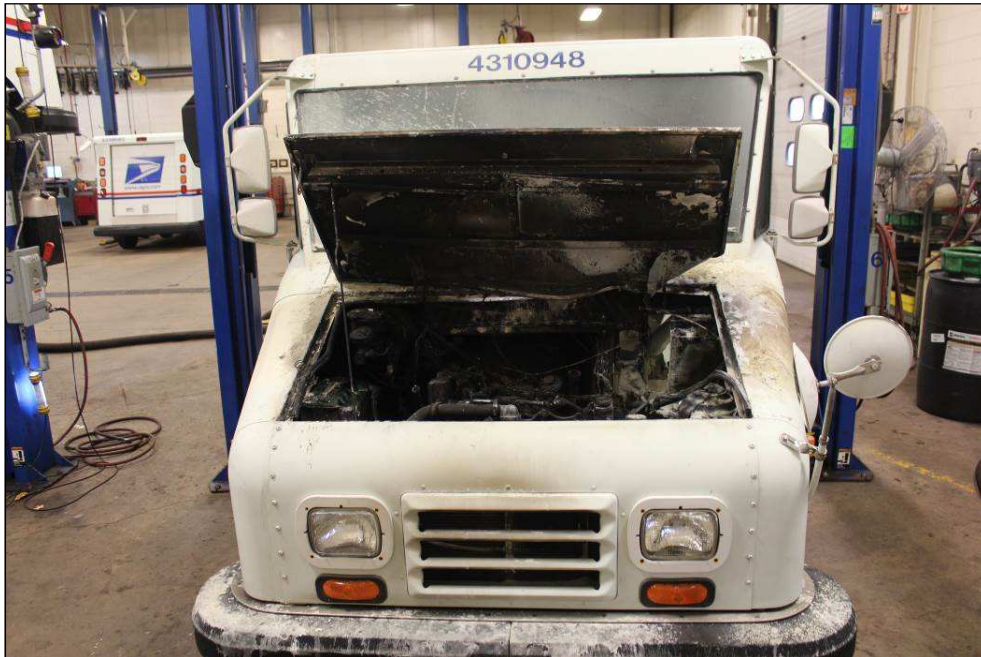
Photograph 1
View of the fire damaged LLV.

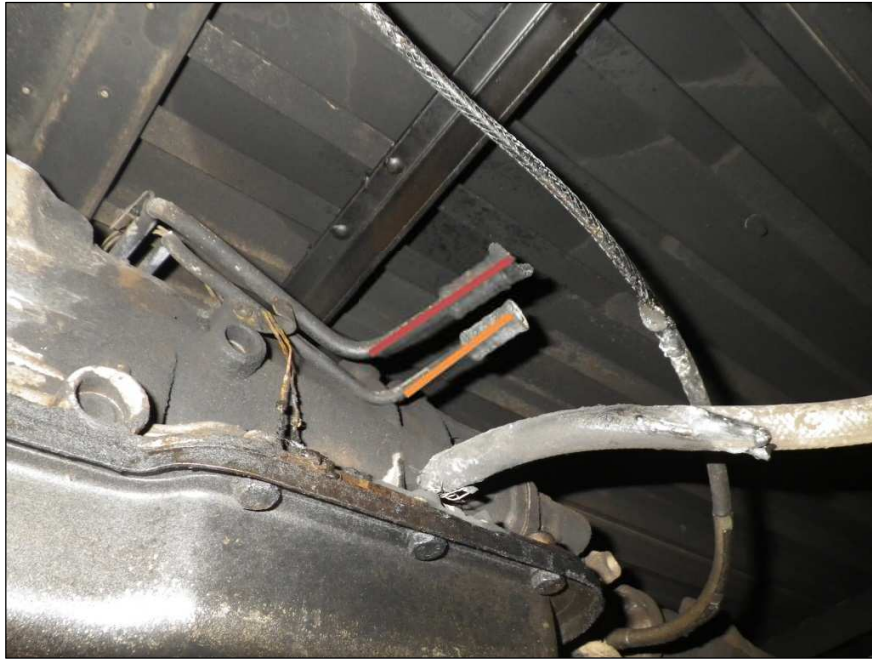
Photograph 3

View of fire damaged fuel lines, two factory hose clamps and fire damaged cable. Red line is supply, and orange line is return.

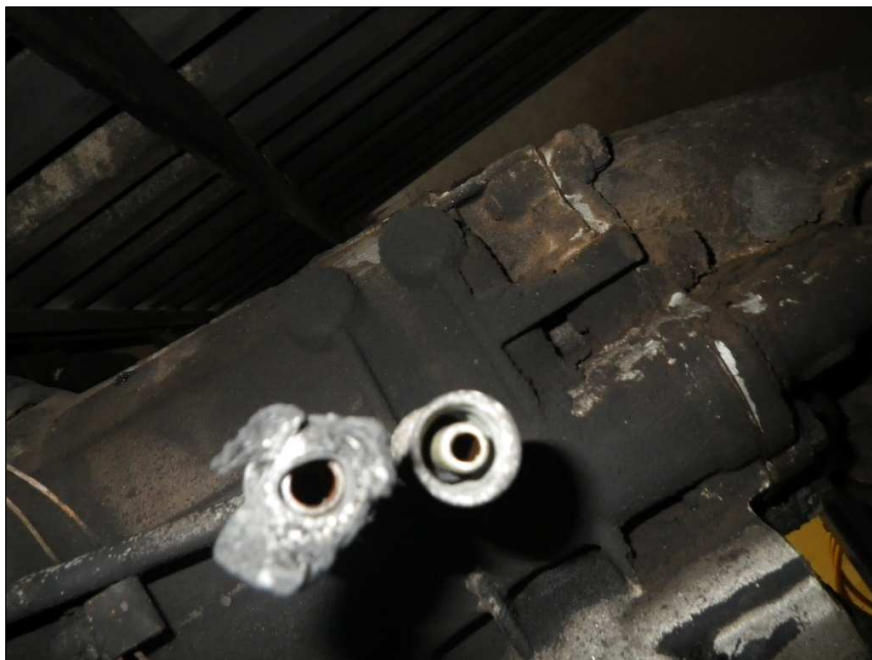
Photograph 4

View of two factory fuel clamps. Right side line (return) is free of any debris.

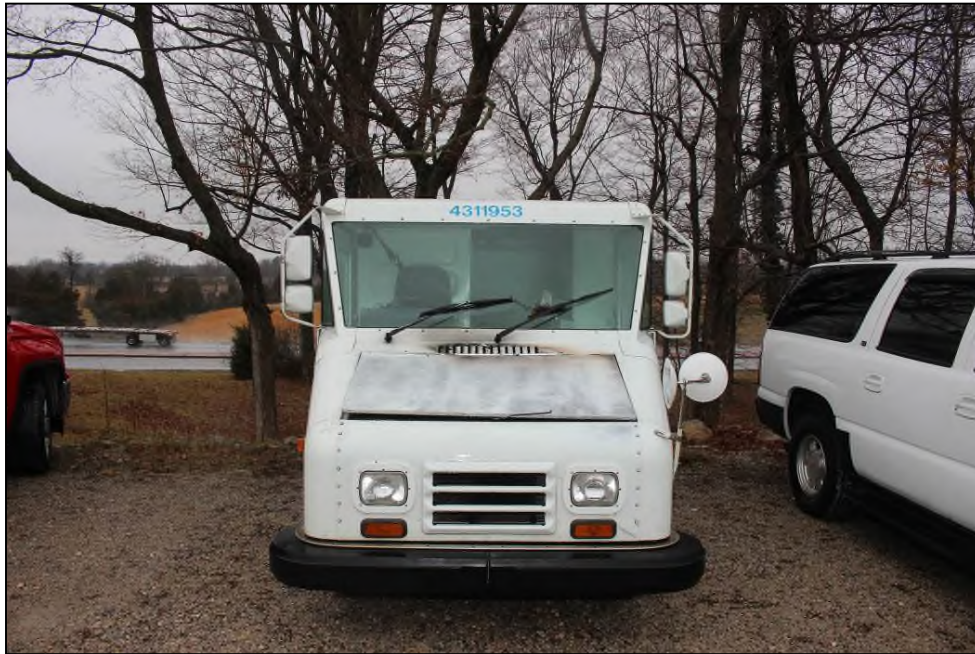
Photograph 1

View of from the front with fire damage along the vent behind the hood.

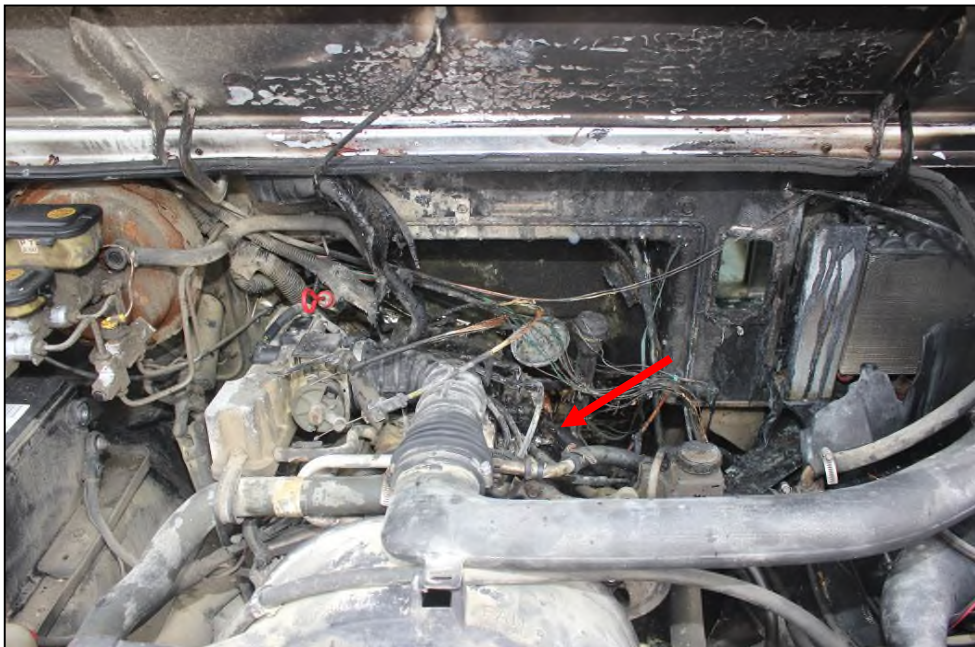
Photograph 2

View of engine compartment area of origin noted.

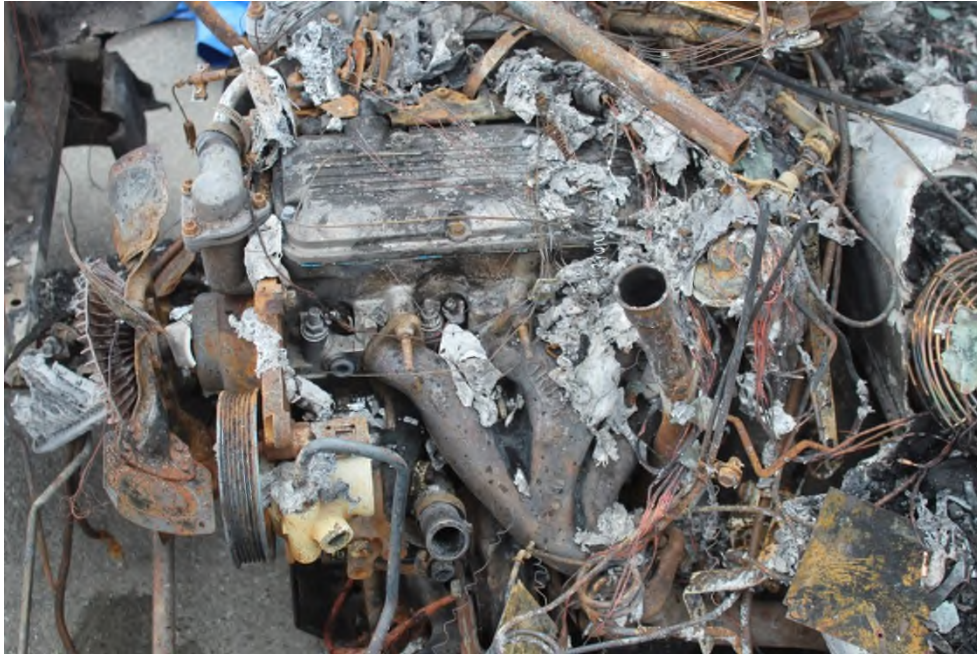
Photograph 3

A view of the engine compartment.

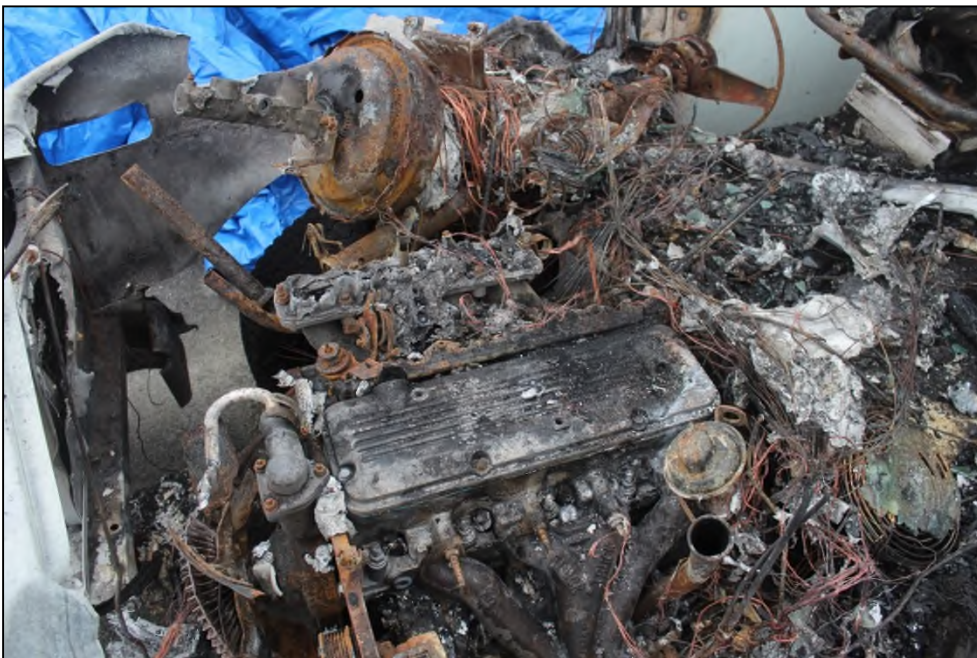
Photograph 4

A view of the engine compartment.

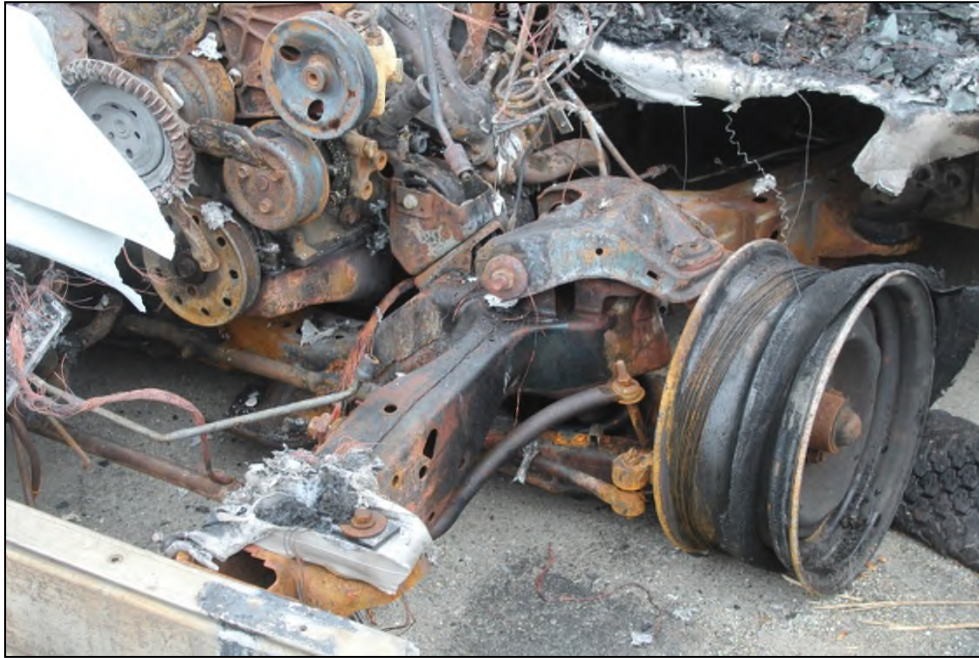
Photograph 5

A view of the engine compartment mail side lower area.

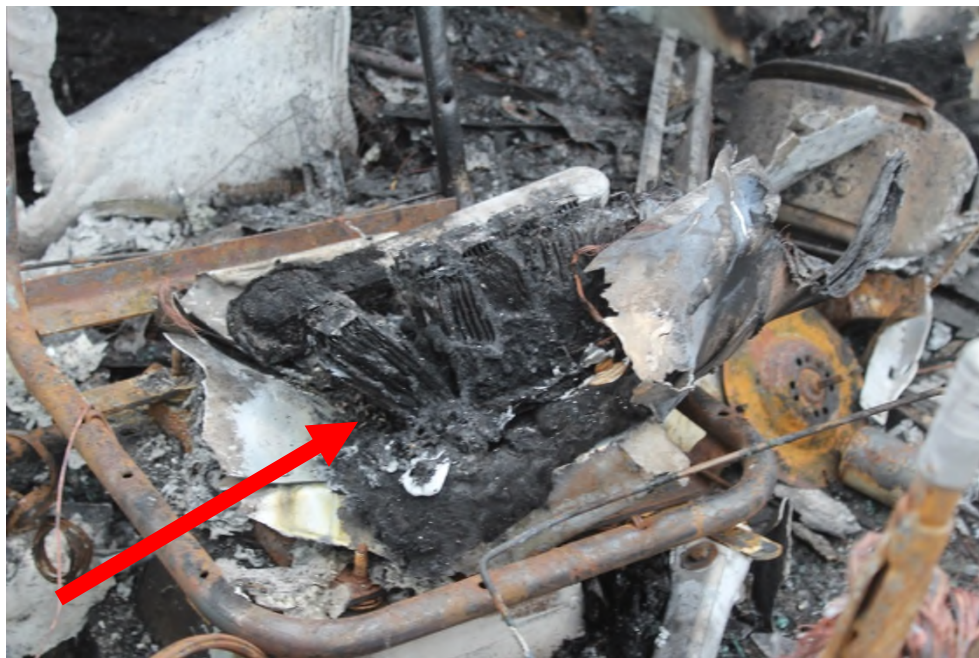
Photograph 6

Remains of the battery.

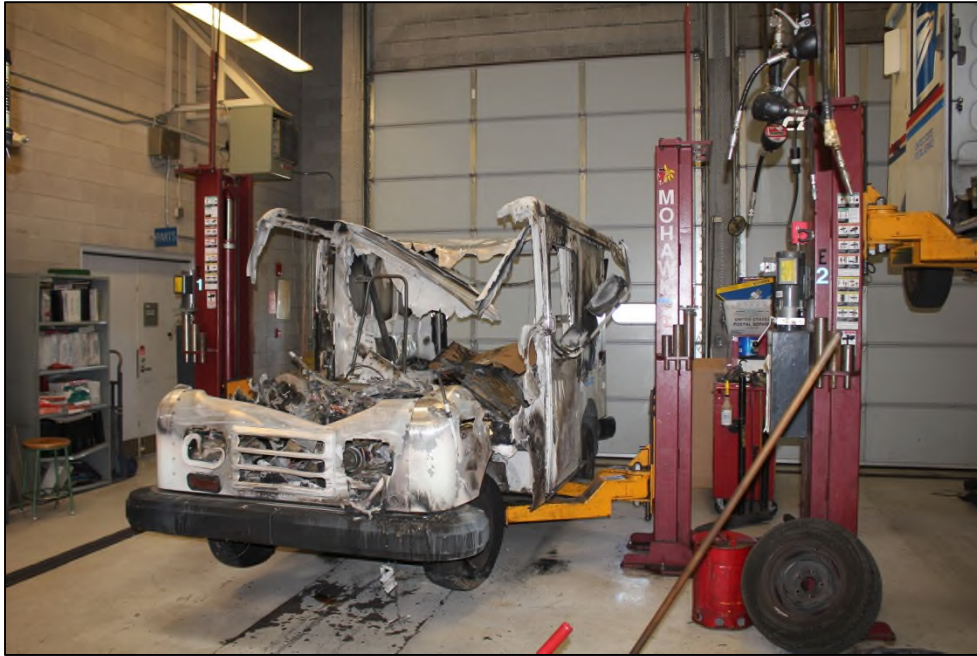
Photograph 1

View of the fire-related damage to the exterior of the LLV.

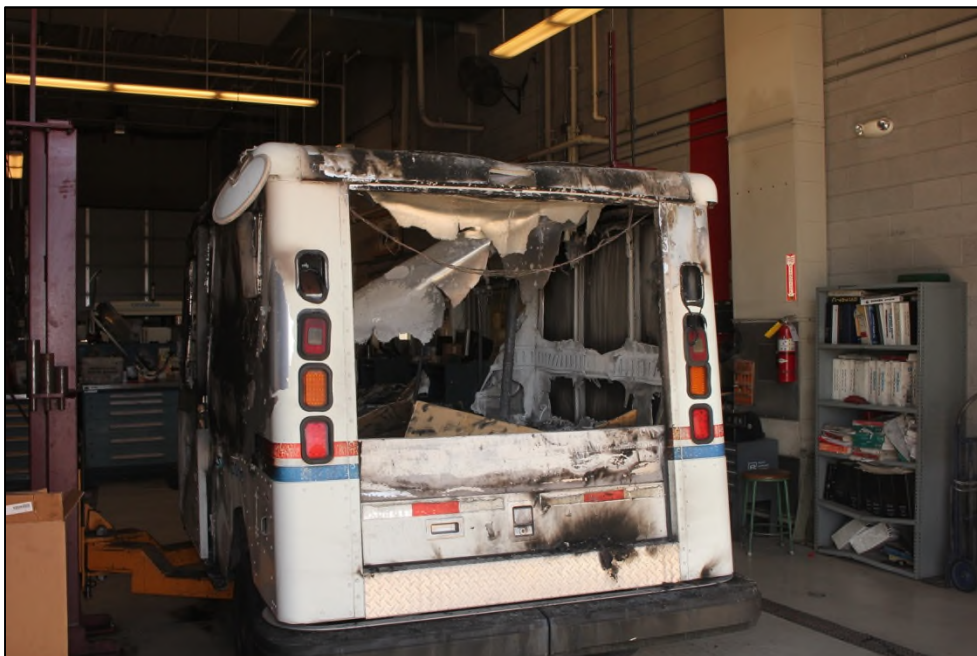
Photograph 2

View of the fire-related damage to the exterior of the LLV.

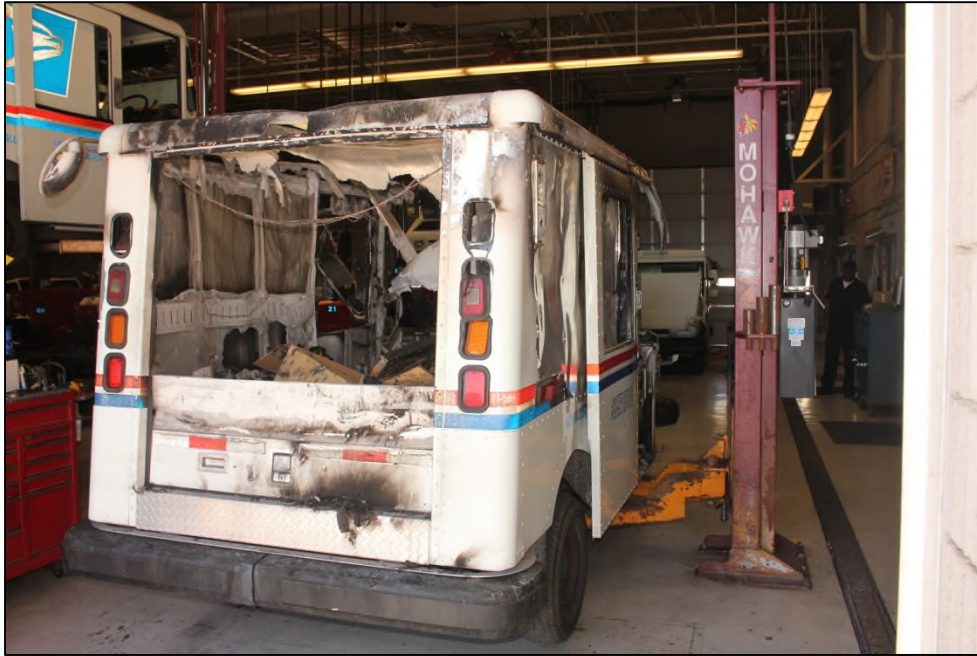
Photograph 3

View of the fire-related damage to the exterior of the LLV.

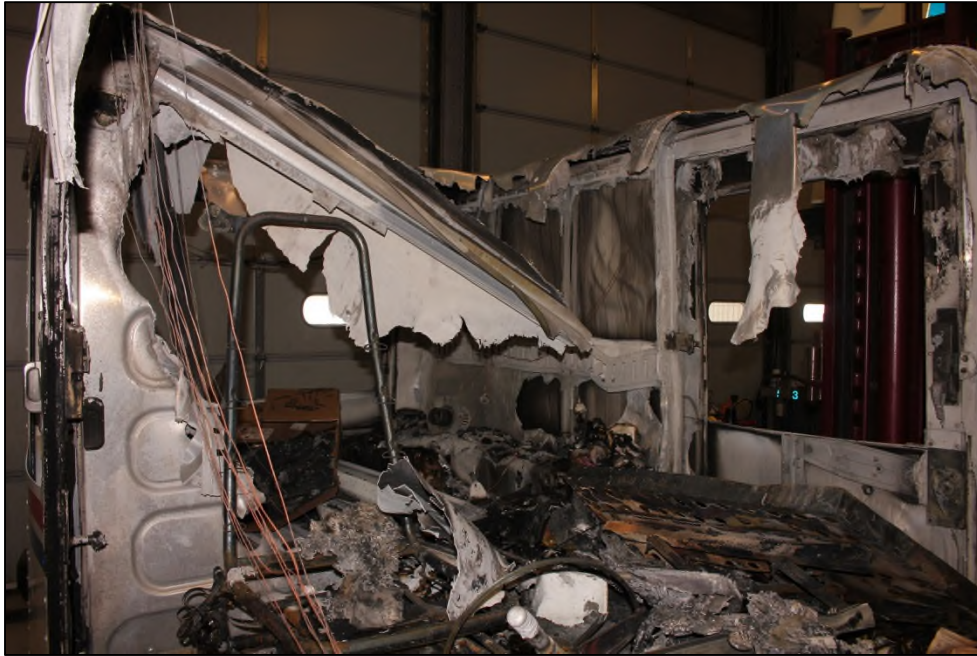
Photograph 5

View of the fire-related damage to the cargo compartment of the LLV.

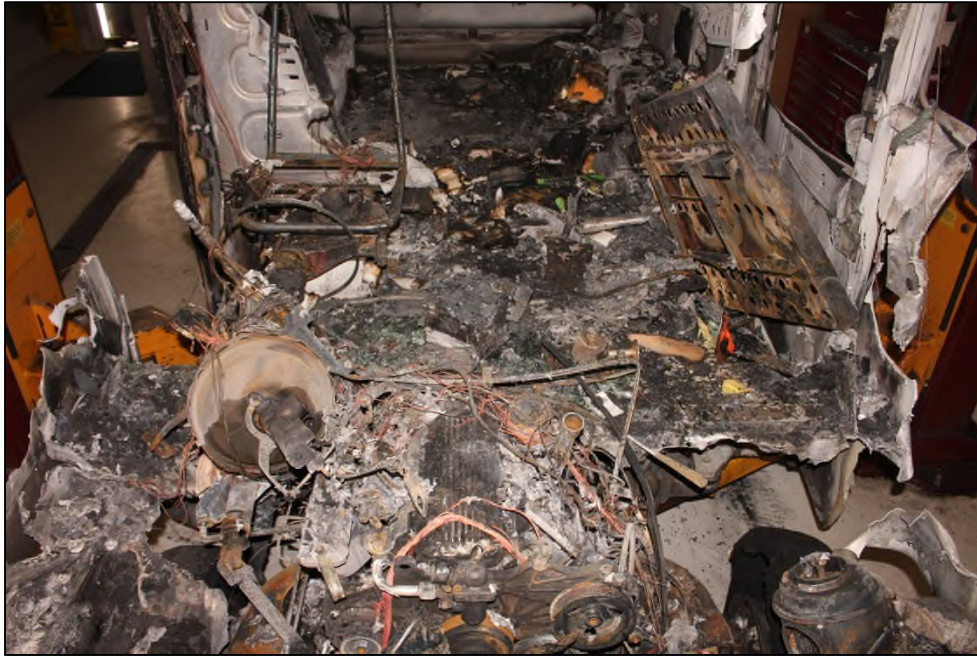
Photograph 7

The examination of the engine compartment revealed severe fire-related damage. The 1994 GMC LLV 4313395 was powered by an inline mounted gasoline-fuel injected, four-cylinder engine with rear wheel drive and an automatic transmission. We inspected the radiator, radiator shroud, air intake system, fuel filter system, fuel lines, belts, hoses, battery, battery cables insulation, battery box, electrical wiring, engine compartment wiring harness, master cylinder, and all plastic components within the upper engine compartment which revealed extensive fire-related damage. The lower engine compartment showed evidence of oil leakage although the engine dipstick, which indicated the oil level was within operating levels. The engine block, heads, exhaust manifold, alternator, brake booster, transmission, and remaining noncombustible components also sustained severe fire related damage (**Photographs 7 through 9**). The LLV had a GM fuel filter system.

View of the engine, passenger and cargo compartments of the LLV.

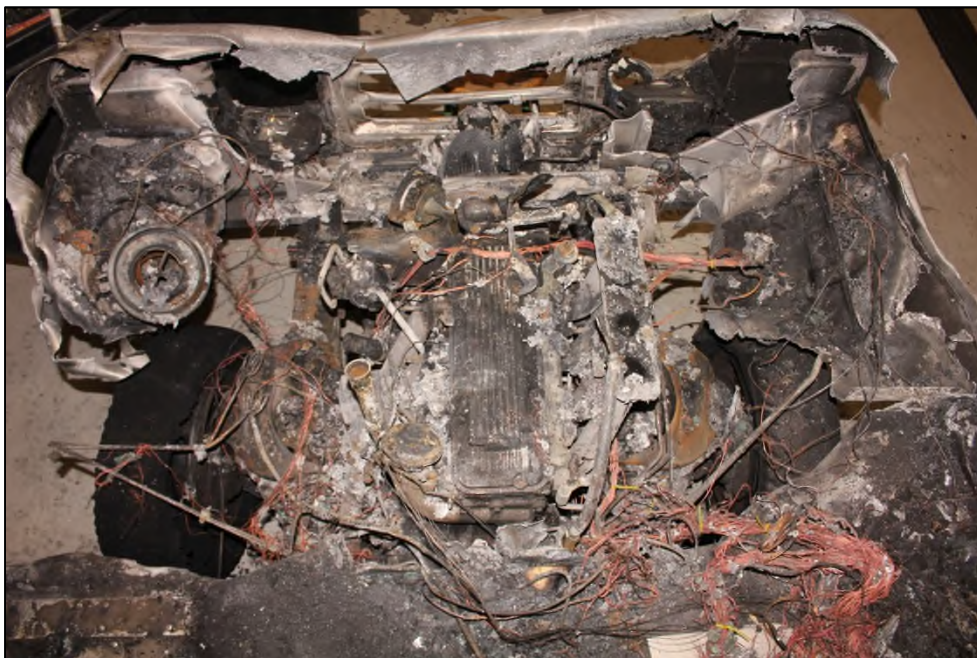
Photograph 8

View of the fire-related damage to the engine compartment of the LLV.

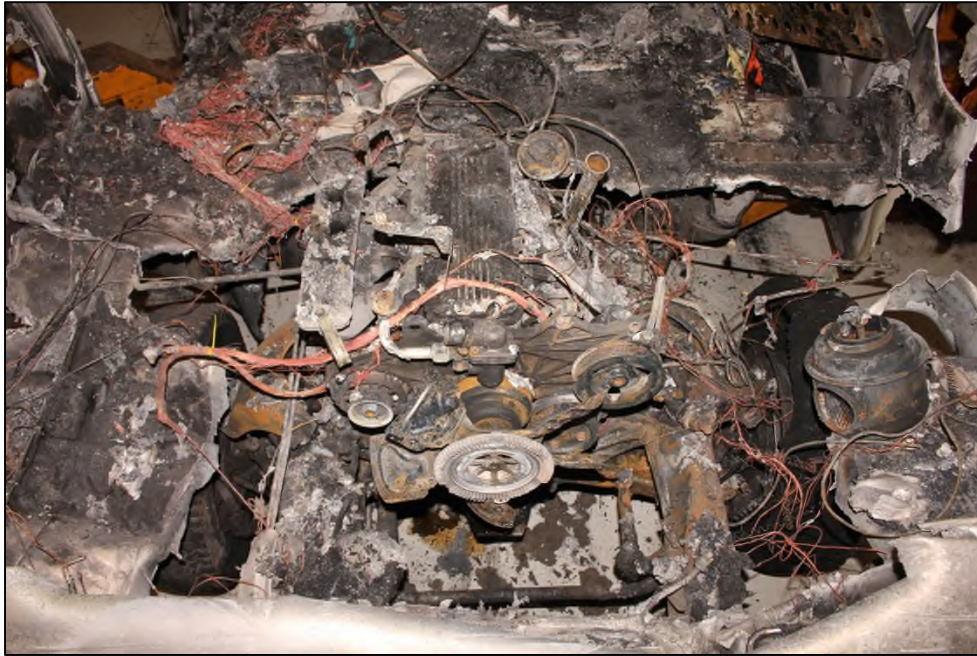
Photograph 9

View of the fire-related damage to engine compartment of the LLV.

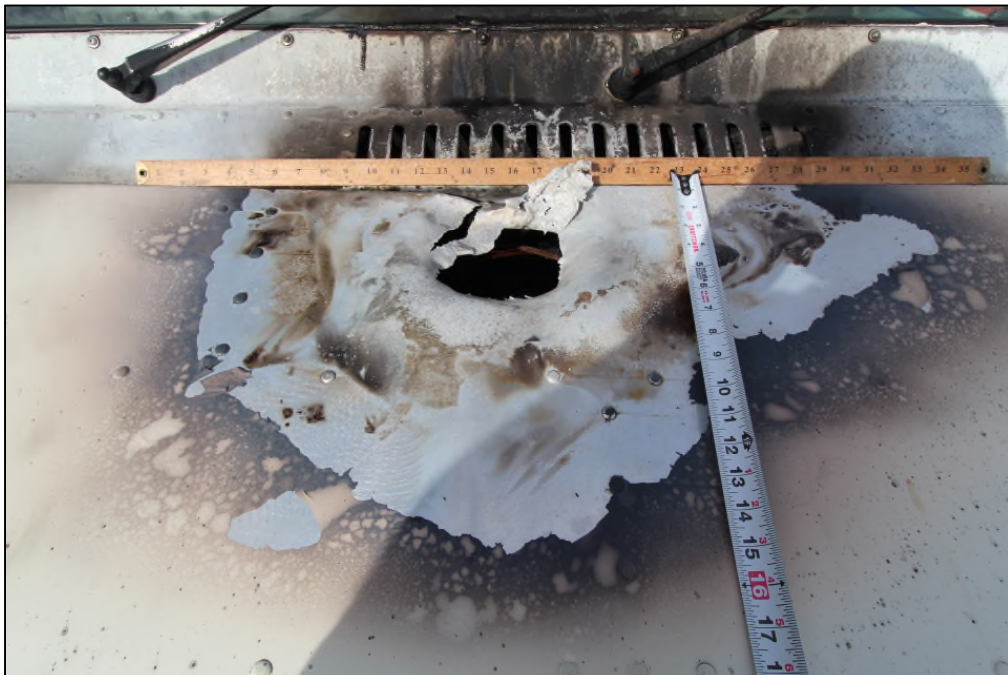
Photograph 2

Pattern of localized fire damage.

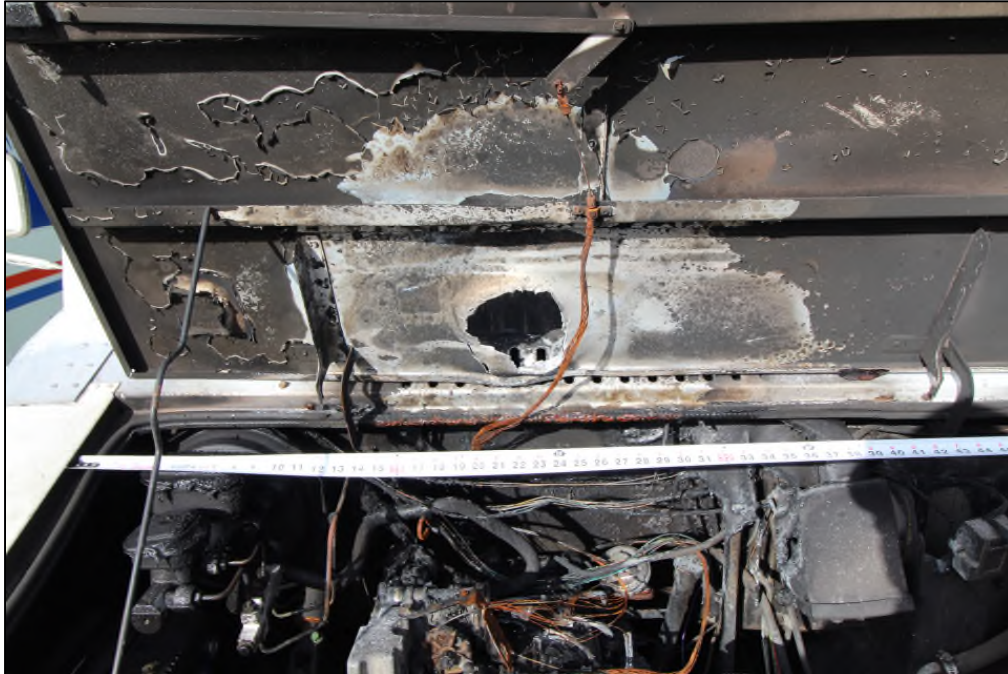
Photograph 3

Engine view of fire damage.
